National Transportation Safety Board

Marine Accident Brief

Accident No.: DCA-06-MF-016

Accident Type: Engineroom fire

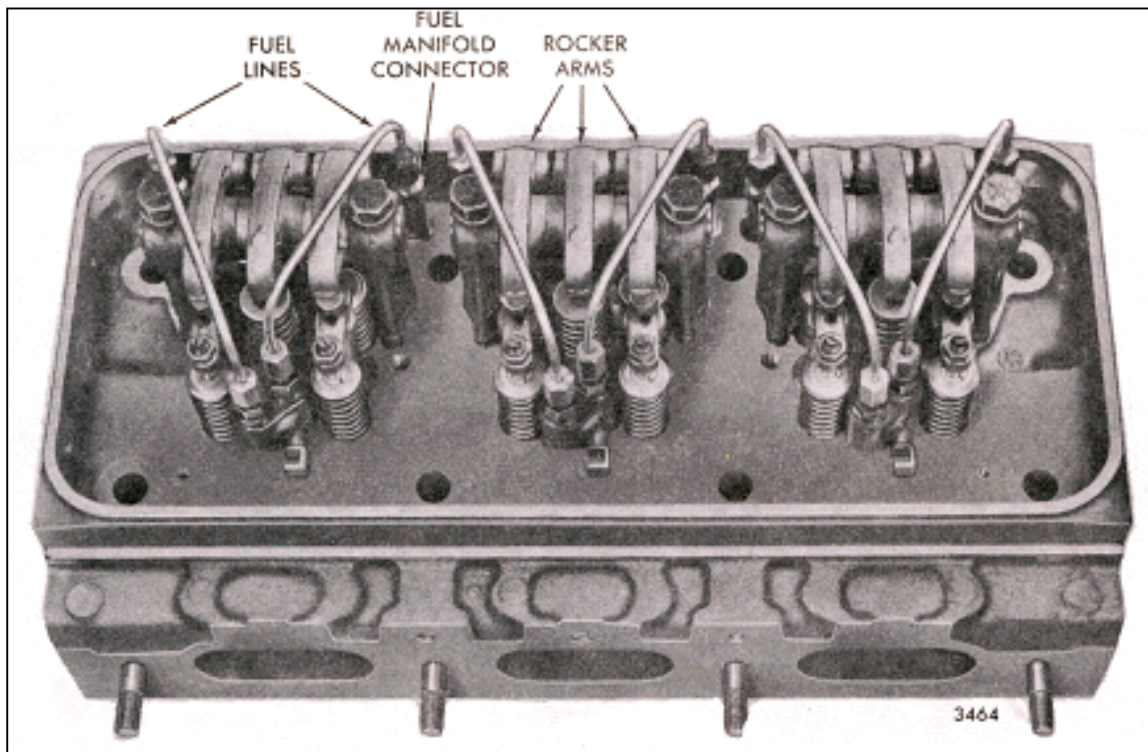
The procedure in the manufacturer's service manual for ensuring that fuel jumper lines are securely in place after replacing the lines is to run the engine with the valve cover off, which makes it possible to observe the jumper lines for any leaks. A Detroit Diesel marine service engineer stated that running the engine with a disconnected fuel jumper line would be like "running a garden hose inside the engineroom." If the valve cover was off, the mechanic should have been able to see fuel leaking from the jumper line that investigators found disconnected after the fire (see "Wreckage" section).

Figure 3. Typical fuel injector assembly in Detroit Diesel engine cylinder.

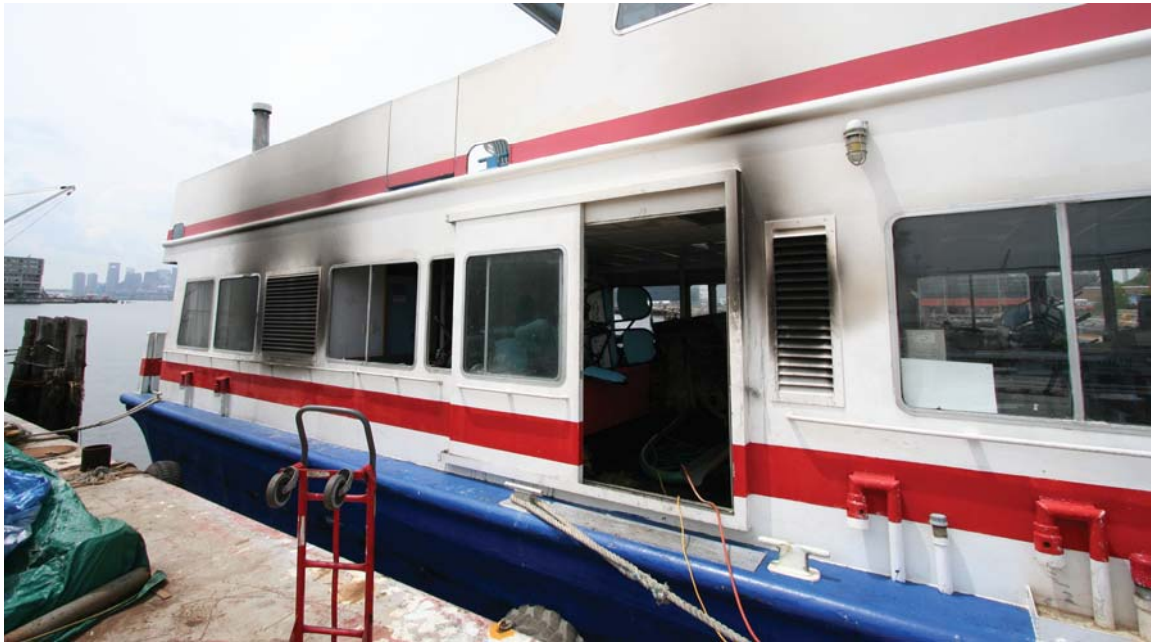
The pilothouse and upper deck were not damaged by the fire. The exterior of the main deck exhibited soot stains at the ventilation grills on both sides of the vessel, more pronounced on the starboard side (figure 6). The carpet in the interior of the main deck was charred on the port side, next to the port engine room air intake duct. Seven windows around the main deck were broken (firefighters had broken them to vent smoke while fighting the fire), and surfaces on the upper and main decks were dusted with soot.

Figure 6. Smoke damage to outside of *Massachusetts's* main deck, starboard side.

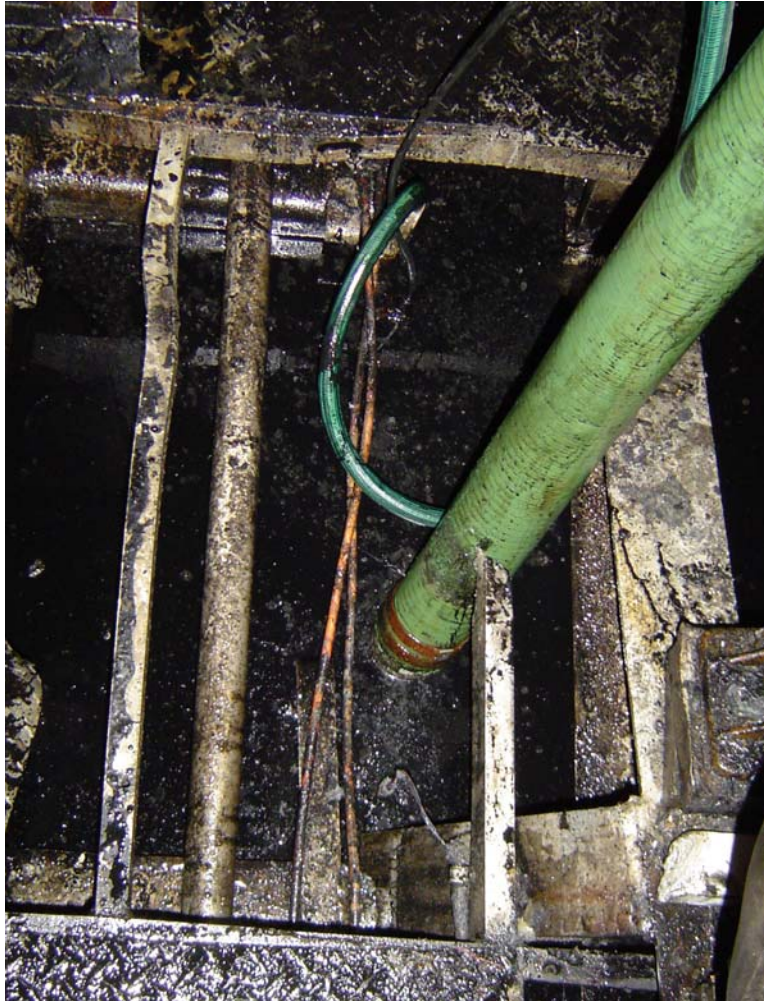
Thermal damage was most severe above and beside the port inboard engine. Above the engine, aluminum bars approximately 1/4 inch thick and 2 inches deep that spanned the length of the overhead were melted and sagging, and a vertical aluminum column extending from the floor to the overhead had softened, fractured, and bent out of alignment. Between the port and starboard inboard engines, a hole approximately 1 1/2 feet in diameter had melted through the aluminum decking, and the decking's support structure was melted and deformed (figure 7).

Figure 7. Melted and deformed floor supports and decking next to port inboard engine, looking down. (Large green hose on right and small green garden hose behind it were inserted to control water in bilges after accident; neither was part of vessel's normal equipment.)

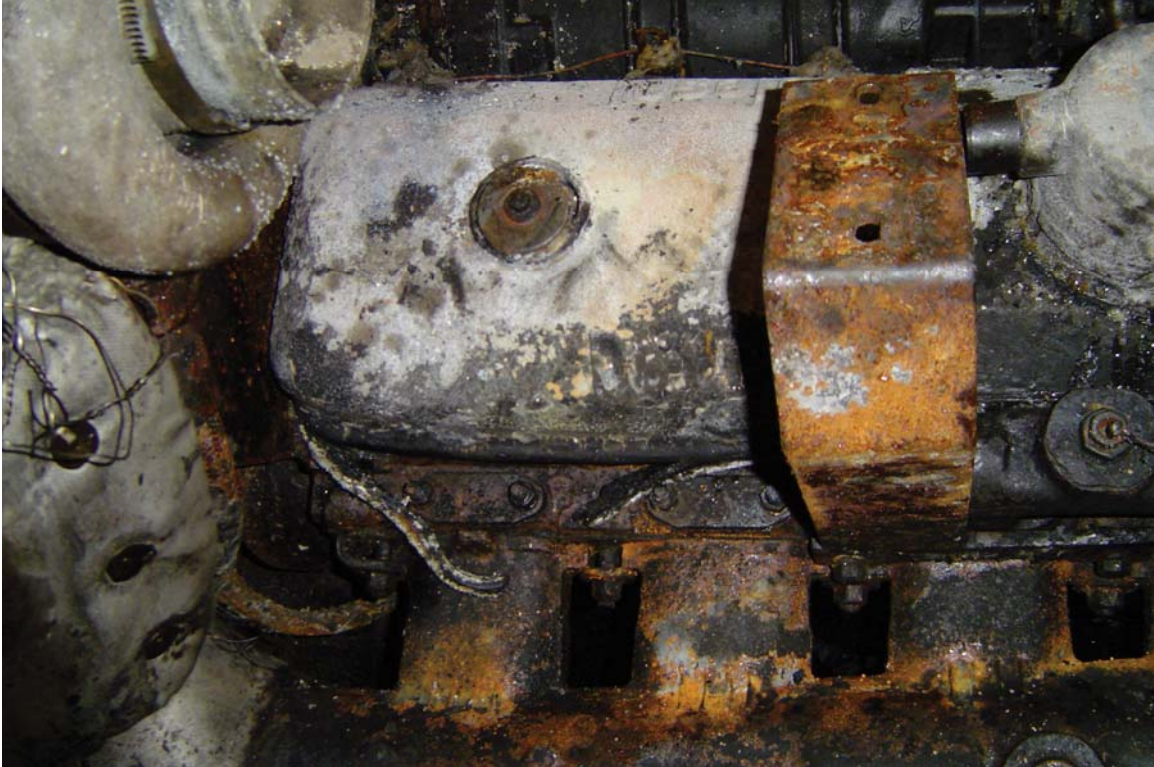
Engines. The most extensive fire damage was to the port inboard engine, which had especially severe thermal damage on the inboard side.²⁷ In that area, the valve cover was deformed, and the gasket protruded from underneath (figure 8). After removing the valve cover, investigators found a disconnected fuel jumper line to the injector on the No. 3 cylinder (figure 9).

Figure 8. Inboard valve cover and protruding gasket, port inboard engine.

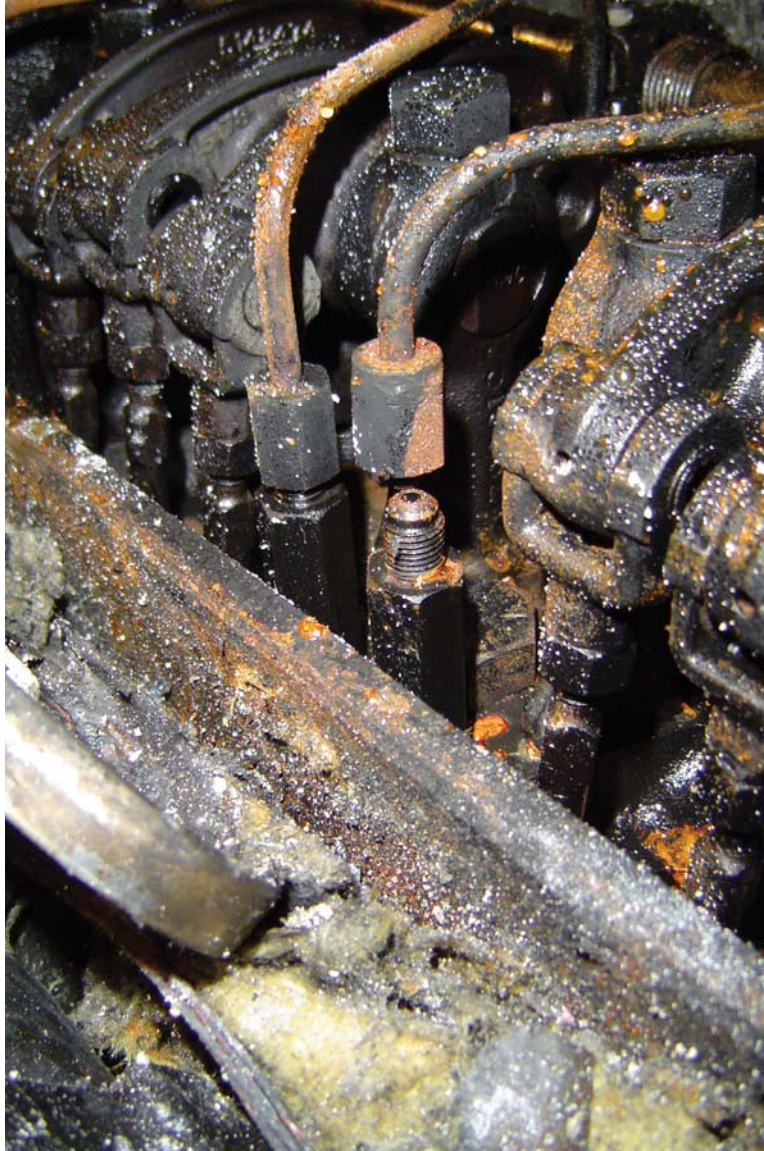
Figure 9. Disconnected fuel line on No. 3 cylinder of port inboard engine.

When investigators examined the wreckage of the *Massachusetts*, they discovered, as described above, that one of the fuel jumper lines on the port inboard engine was disconnected. The disconnected jumper line had been attached to the fuel injector on the No. 3 cylinder on the engine's inboard side. The fuel jumper line and its mating surface were sent to the Safety Board's materials laboratory in Washington, D.C., for examination. The examination found no mechanical damage to the threads of the connector fittings or any other mechanical reason for the jumper line to have become disconnected. Fuel leakage from the disconnected fuel jumper line would have allowed fuel to flow to the engine crankcase, accumulate, escape through the crankcase vent, contact the hot surface of the exhaust manifold below, and ignite.

The National Transportation Safety Board determines that the probable cause of the fire on board the *Massachusetts* was the ignition of diesel fuel by contact with a hot engine surface, which occurred because a fuel line attached to a fuel injector was not properly connected during engine maintenance by a contract mechanic. Contributing to the extent of the damage was the absence of a fixed fire detection and suppression system, which precluded the crew from receiving timely notification of the fire and which allowed the blaze to spread throughout the engine room.

Require that all small passenger vessels certificated to carry more than 49 passengers, regardless of date of build or hull material, be fitted with an approved fire detection system and a fixed fire suppression system in their engine rooms. (M-07-1) (Supersedes Safety Recommendations M-02-6 and M-02-8.)
