FIRE ON BOARD THE LIBERIAN PASSENGER SHIP *ECSTASY*  
MIAMI, FLORIDA  
JULY 20, 1998

**NTSB/MAR-01/01  
PB2001-916401  
Notation 7357  
Adopted May 1, 2001**

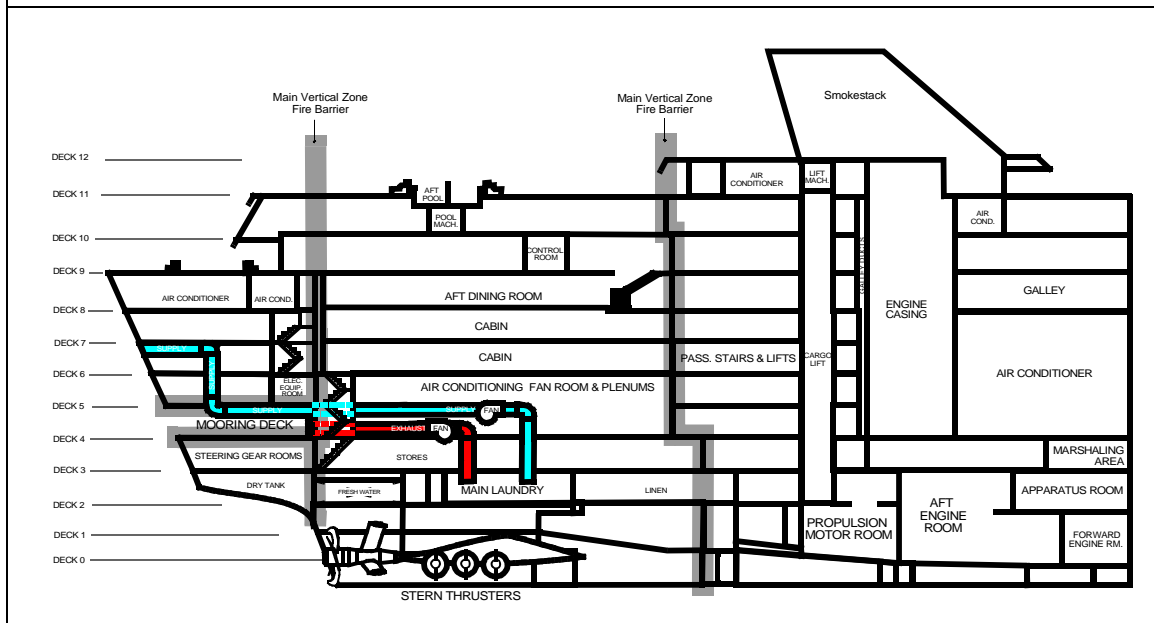
Figure 1. On the day of the accident, the fire alarm panel on the bridge indicated that the first alarm activated in the main laundry on deck No. 2. The ventilation system for the laundry penetrated a main vertical zone (MVZ) and exhausted onto the mooring deck. Other early fire alarms indicated that detectors activated in the stern thruster room, the air conditioning plenum between decks No. 4 and 6, an electrical room above the mooring deck, and both steering gear rooms below the mooring deck.

The two exhaust systems (figure 1) were separate from each other until the ducts exited into the aft mooring deck plenum. The blowers for each of the systems were in the double-deck air conditioning room that extended upward from deck No. 4. According to Carnival Cruise Lines' records, the mangle exhaust blower had a calculated linear flow velocity of 7.3 meters per second (m/s).<sup>17</sup>

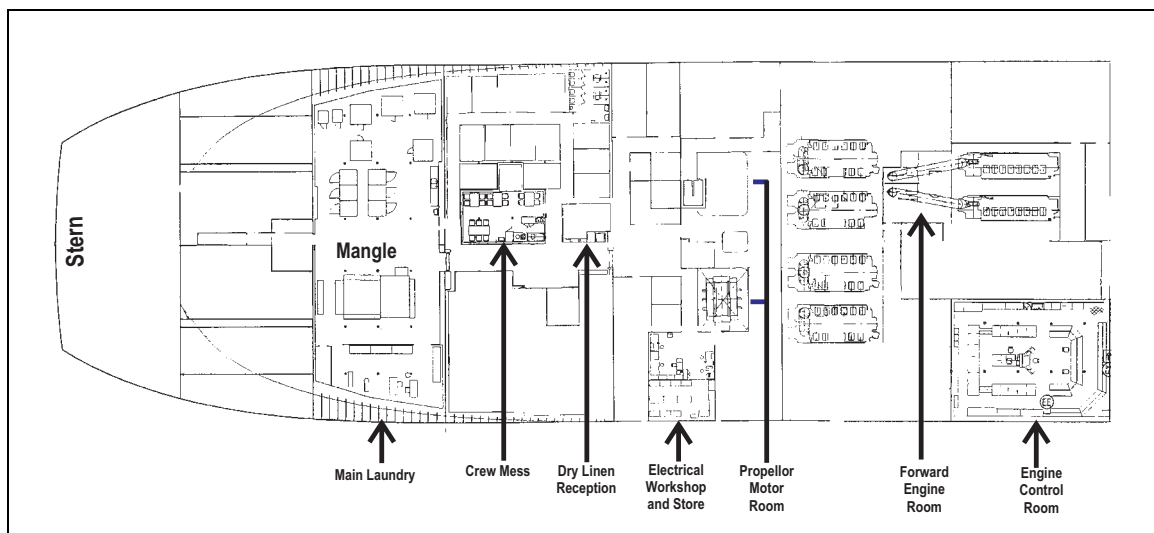
About 1630, a mangle<sup>3</sup> in the *Ecstasy's* main laundry (figure 2) malfunctioned. The laundry manager telephoned a repair request to the hotel engineer, who, in turn, paged the on-call galley fitter (first fitter). The first fitter said that he was in the fitters' workshop on deck No. 3, preparing to go off duty at 1730, when he was paged and told to go to the main laundry. He said that the laundry manager told him that the mangle was not working properly, and that its roller needed to be adjusted.

**Figure 2. Layout of deck No. 2, aft of the smokestack. In the main laundry, the washers and dryers were on the port side of the ship, and the mangle was on the starboard side.**

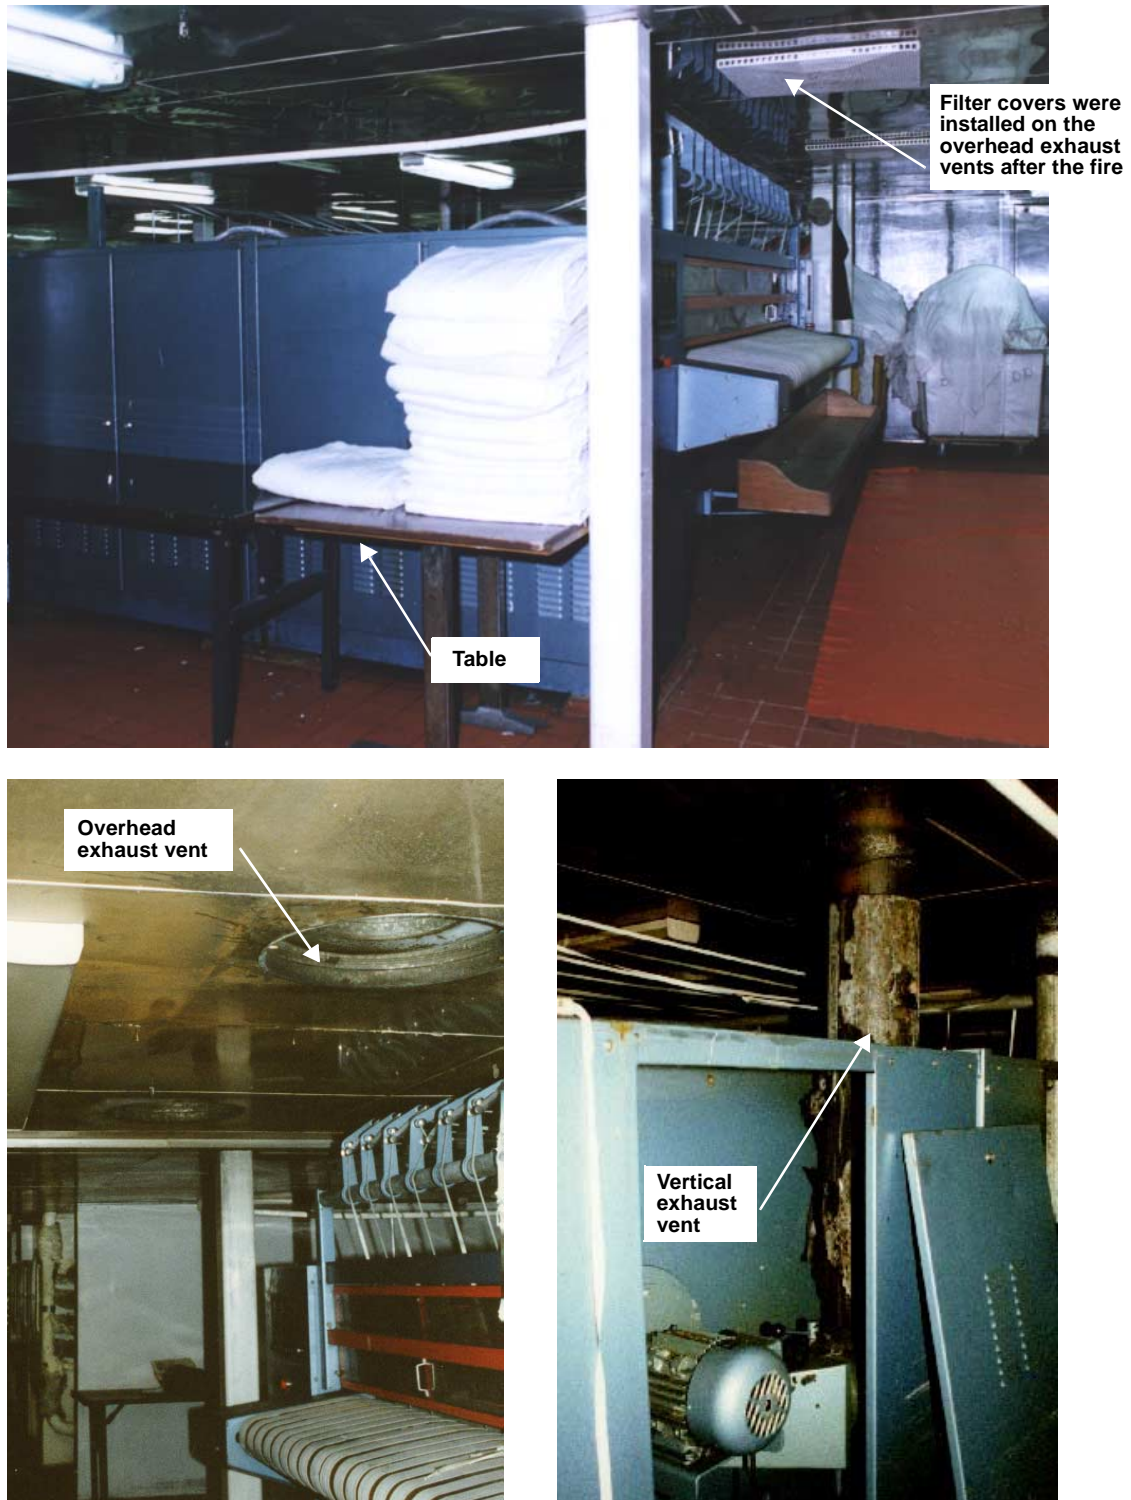
Figure 3. (Top) The mangle in the main laundry after Carnival made postaccident repairs to the area. The tables shown are in about the same location as the table on which the fitters placed the welding machine on the day of the fire. (Bottom left) The large uncovered opening in the overhead was one of three vents above the mangle that exhausted air and lint into the ventilation system. (Bottom right) Two fan units drew heat and lint from the pressing rollers into vertical ducts that were connected to the overhead ducts of the main laundry ventilation system.

The main laundry was on deck No. 2, within MVZ 2. The mangle (figure 3) was on the starboard side of the laundry space. When operating the mangle, laundry workers placed damp linens on the loading side of the machine. The mangle had strings coated with wax that directed the linen through the ironing machine's felt-covered rollers. The steam produced by the ironing action was removed by blowers and exhausted into two vertical ducts on the starboard side of the mangle. When workers turned off the mangle, its rollers automatically raised, preventing damage to the roller bed. The vertical ducts that interfaced with the mangle were attached to a main exhaust duct for the machine.

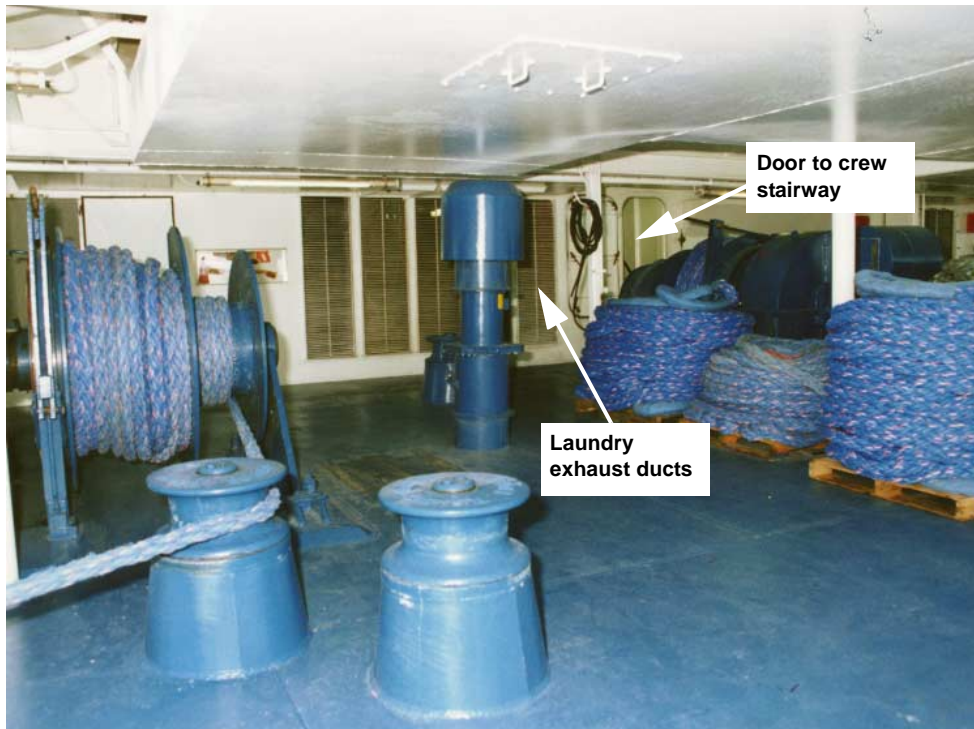
Figure 6a. The ventilation system for the main laundry exhausted onto the mooring deck (shown above), where the synthetic mooring line was spooled on winches or stored on pallets.

At the time of the fire, the mooring deck had 11 lengths of line, each measuring 220-meters and weighing about 900 pounds. The lines included three lengths of polypropylene line that were on the winch drums, seven pallets of polypropylene line, and one pallet of nylon line.

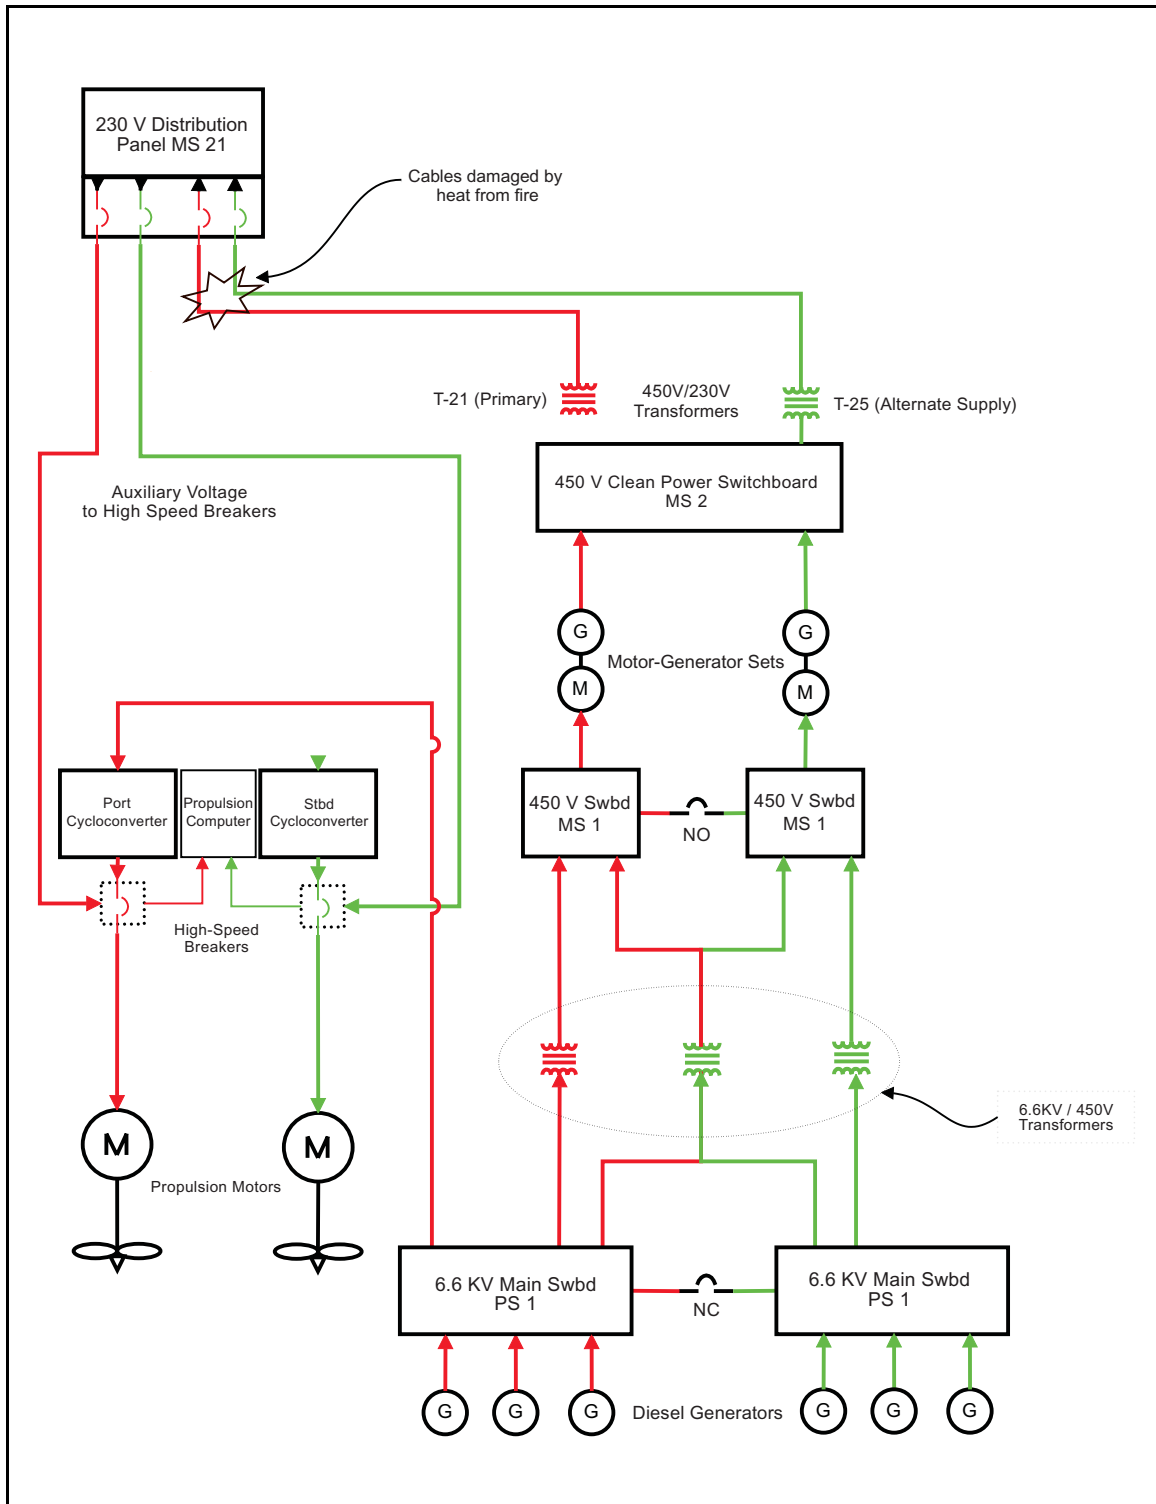
Figure 7. Schematic of the propulsion system's wiring.

The signals indicating the circuit breakers' positions passed through a distribution panel (MS-21) in an electric equipment room on deck No. 5, above the area where the fire occurred. Power cables from transformers supplying the distribution panel were in the ventilation intake plenum that was forward of the aft mooring station.

**Propulsion system.** Investigators noted that electrical cables in the ventilation exhaust plenum near the mooring deck were burned and melted. Some of these cables supplied voltage from an electrical distribution panel in an equipment room near the aft mooring station to the high-speed breakers for the port and starboard propulsion systems.
