Engineroom Fire On Board U.S. Small Passenger Vessel
Queen of the West
Columbia River, near Rufus, Oregon
April 8, 2008

Accident Summary Report

NTSB/MAR-09/04/SUM
PB2009-916404

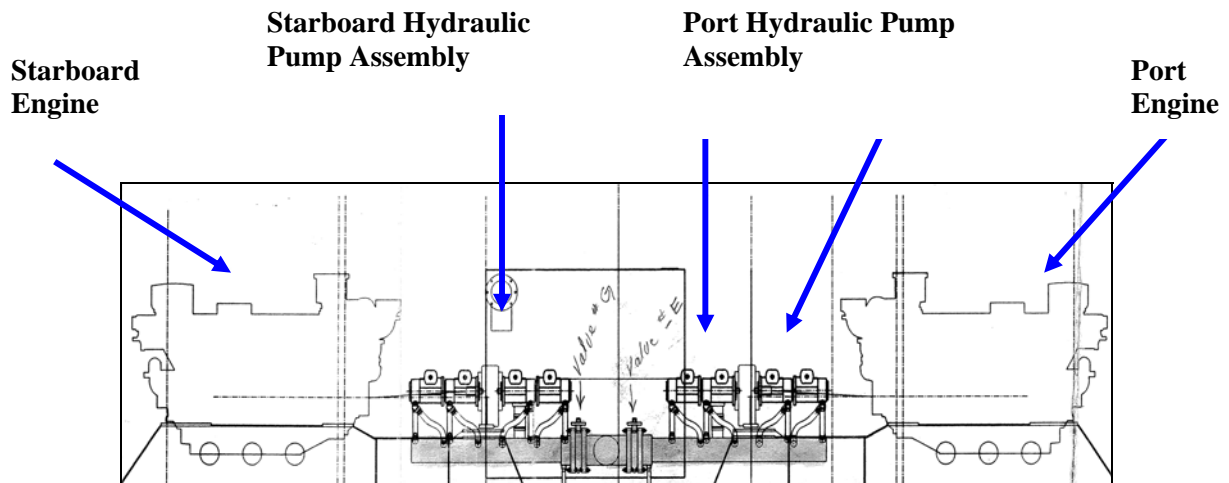
Figure 7. Upper engine level configuration, facing aft.
