National Transportation Safety Board

Marine Accident Brief

Accident No.: DCA-06-MF-016

Accident Type: Engineroom fire

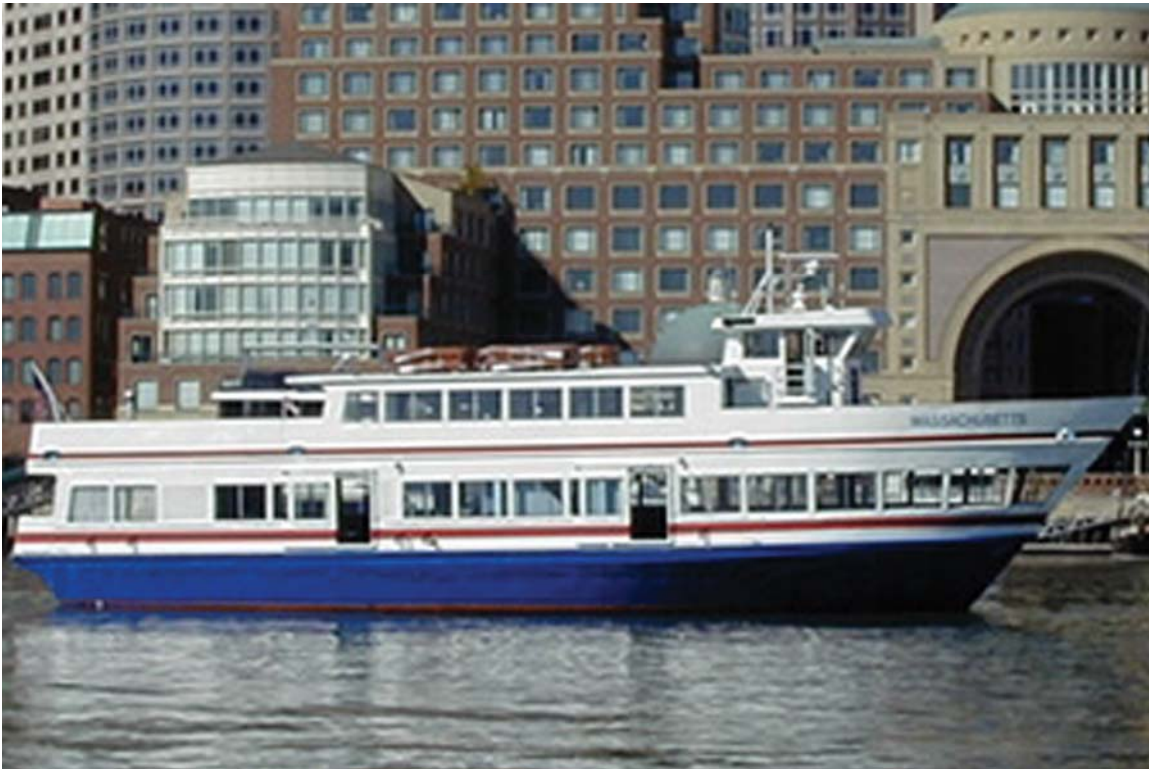
Figure 1. Commuter ferry *Massachusetts* at Rowe's Wharf, Boston. (Photo courtesy Massachusetts Bay Lines)

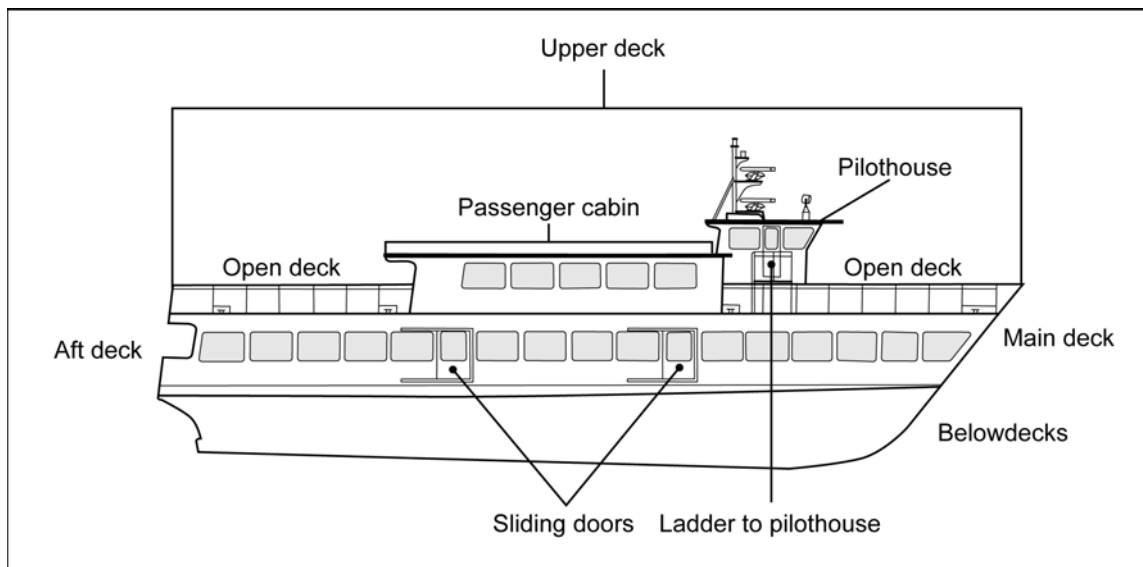
Figure 4. Profile view of the *Massachusetts*. Passengers were carried in the enclosed cabins on the main and upper decks.

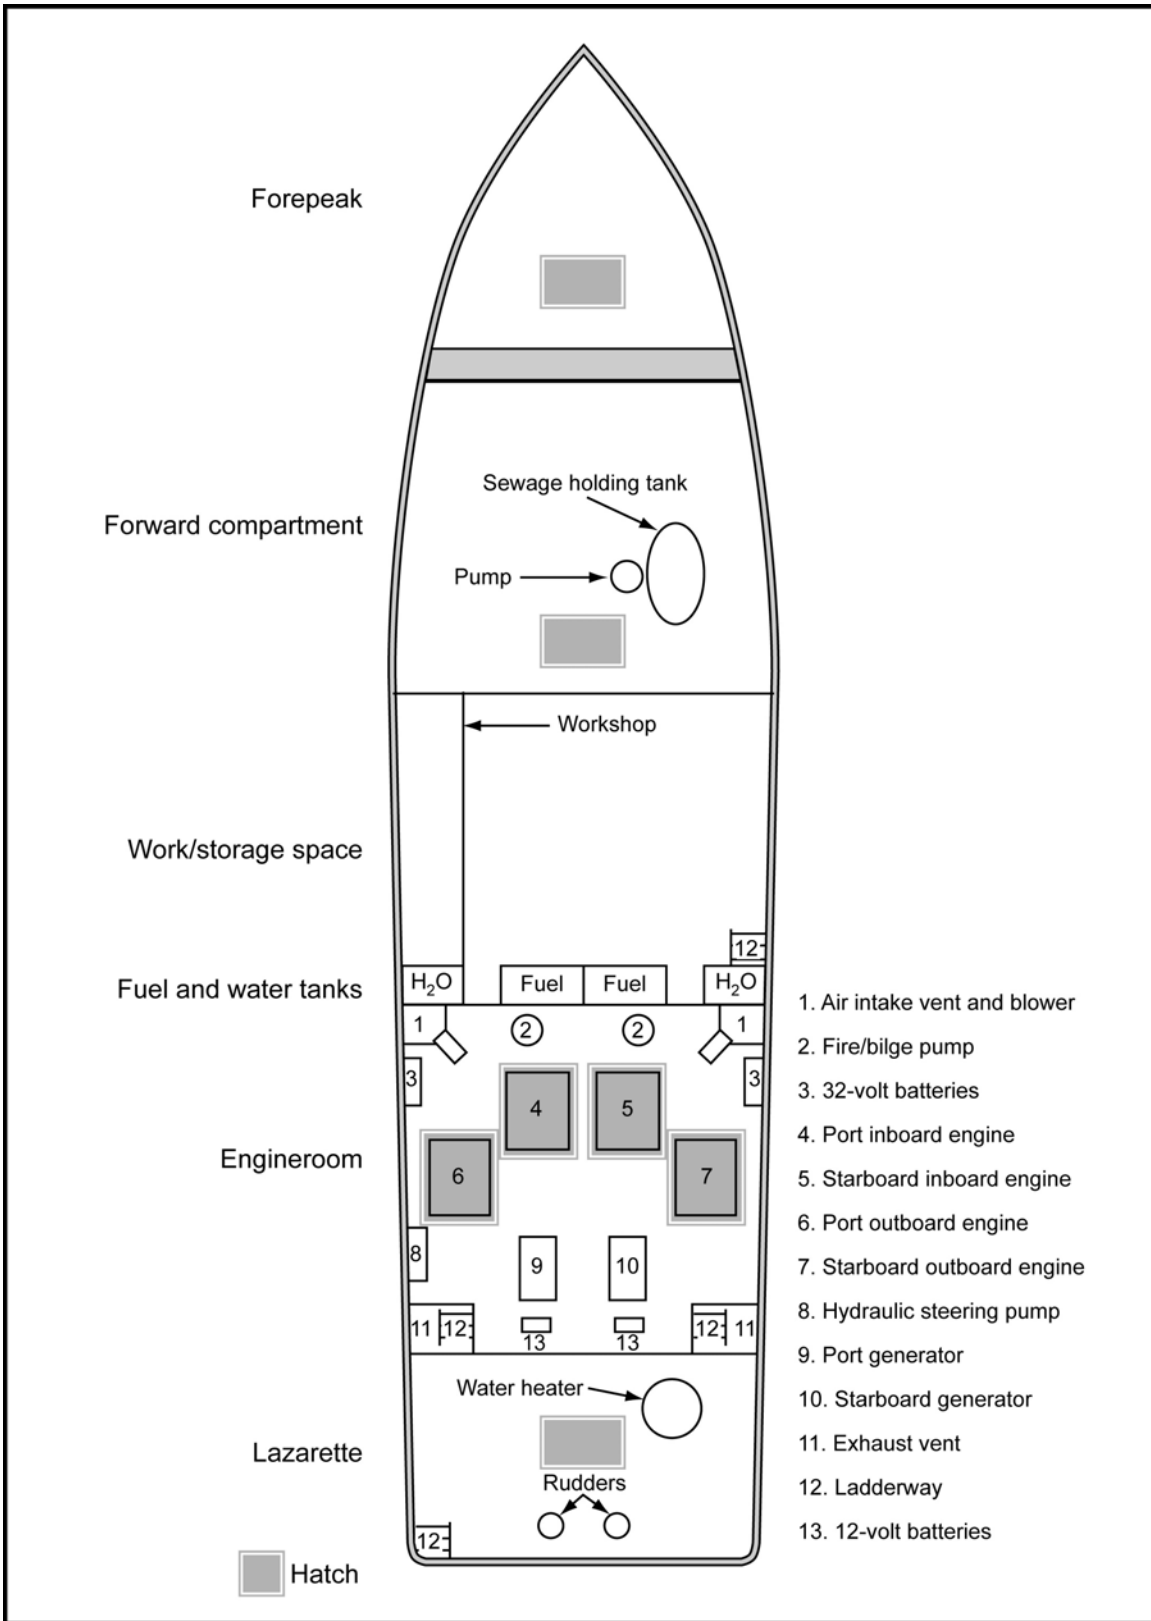
The belowdecks area was divided into six compartments separated by transverse watertight aluminum bulkheads extending upward from the bilges to the main deck (figure 5). The forwardmost compartment (forepeak) contained anchor rope and spare lines. The next compartment (forward compartment) contained a sewage holding tank and macerator pump.²⁵ Aft of the forward compartment was a space that was used to store supplies such as coffee and also contained a small workshop; it was accessible from the main deck by a ladderway forward of the bar area.

Immediately behind the work/storage space was a narrow compartment that held the fuel tanks and potable water tanks. Aft of that was the engineroom, accessed by ladderways forward of the restrooms on each side of the main deck. The engineroom could also be accessed from the main deck by unscrewing any of four large hatches, one over each engine (as shown in figure 5). The aftmost belowdecks compartment (lazarette) contained exhaust piping, a hydraulic cylinder for the steering system, and the vessel's hot water heater. Each of the belowdecks compartments contained a bilge suction well. The lazarette, engineroom, work/storage space, and forepeak were also equipped with high-water bilge alarms.

Figure 5. Belowdecks plan of the *Massachusetts* showing compartments and equipment. Shaded areas indicate hatches (covered openings) in the main deck that provided belowdecks access.
