FIRE ON BOARD THE LIBERIAN PASSENGER SHIP *ECSTASY*  
MIAMI, FLORIDA  
JULY 20, 1998

**NTSB/MAR-01/01  
PB2001-916401  
Notation 7357  
Adopted May 1, 2001**

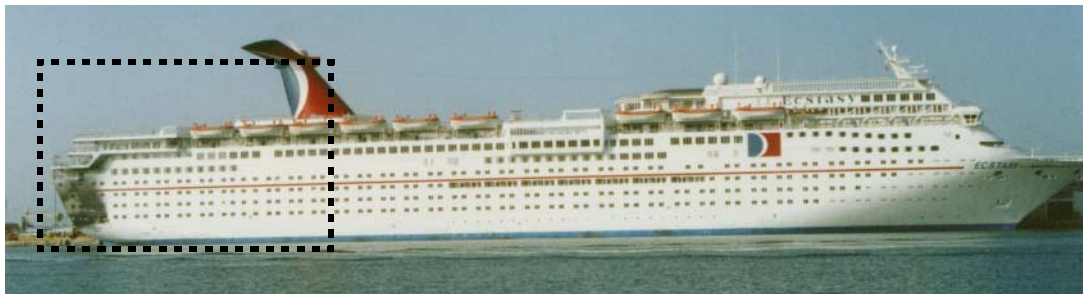
The photograph above shows the *Ecstasy* after the fire. The ship area indicated by the dotted line is illustrated in the cutaway below.

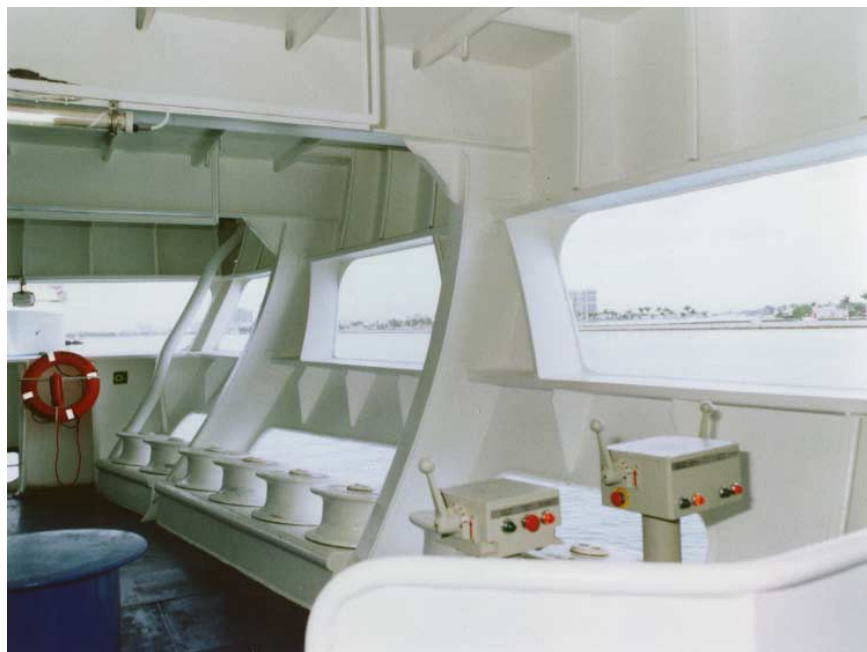
The mooring station on deck No. 4 is aft of the MVZ No. 1 forward bulkhead. The station is a covered space that is open to the weather on the port, starboard, and aft sides. (See figures 6a and 6b.) The station is used only when docking or undocking. The area has three electrically controlled winches that spool the large diameter polypropylene line (rope) that is used to moor the vessel. One winch is on the port side, one is on the starboard side, and one is in the center of the deck. Additional coils of mooring line are stored on wooden pallets on the mooring deck.

Figure 6b. The *Ecstasy's* mooring station is a covered deck area that is open to the weather on the side and rear of the ship.

At the time of the fire, the mooring deck had 11 lengths of line, each measuring 220-meters and weighing about 900 pounds. The lines included three lengths of polypropylene line that were on the winch drums, seven pallets of polypropylene line, and one pallet of nylon line.
